# History of the Wylfa Boilers

An Exercise in Problem Solving

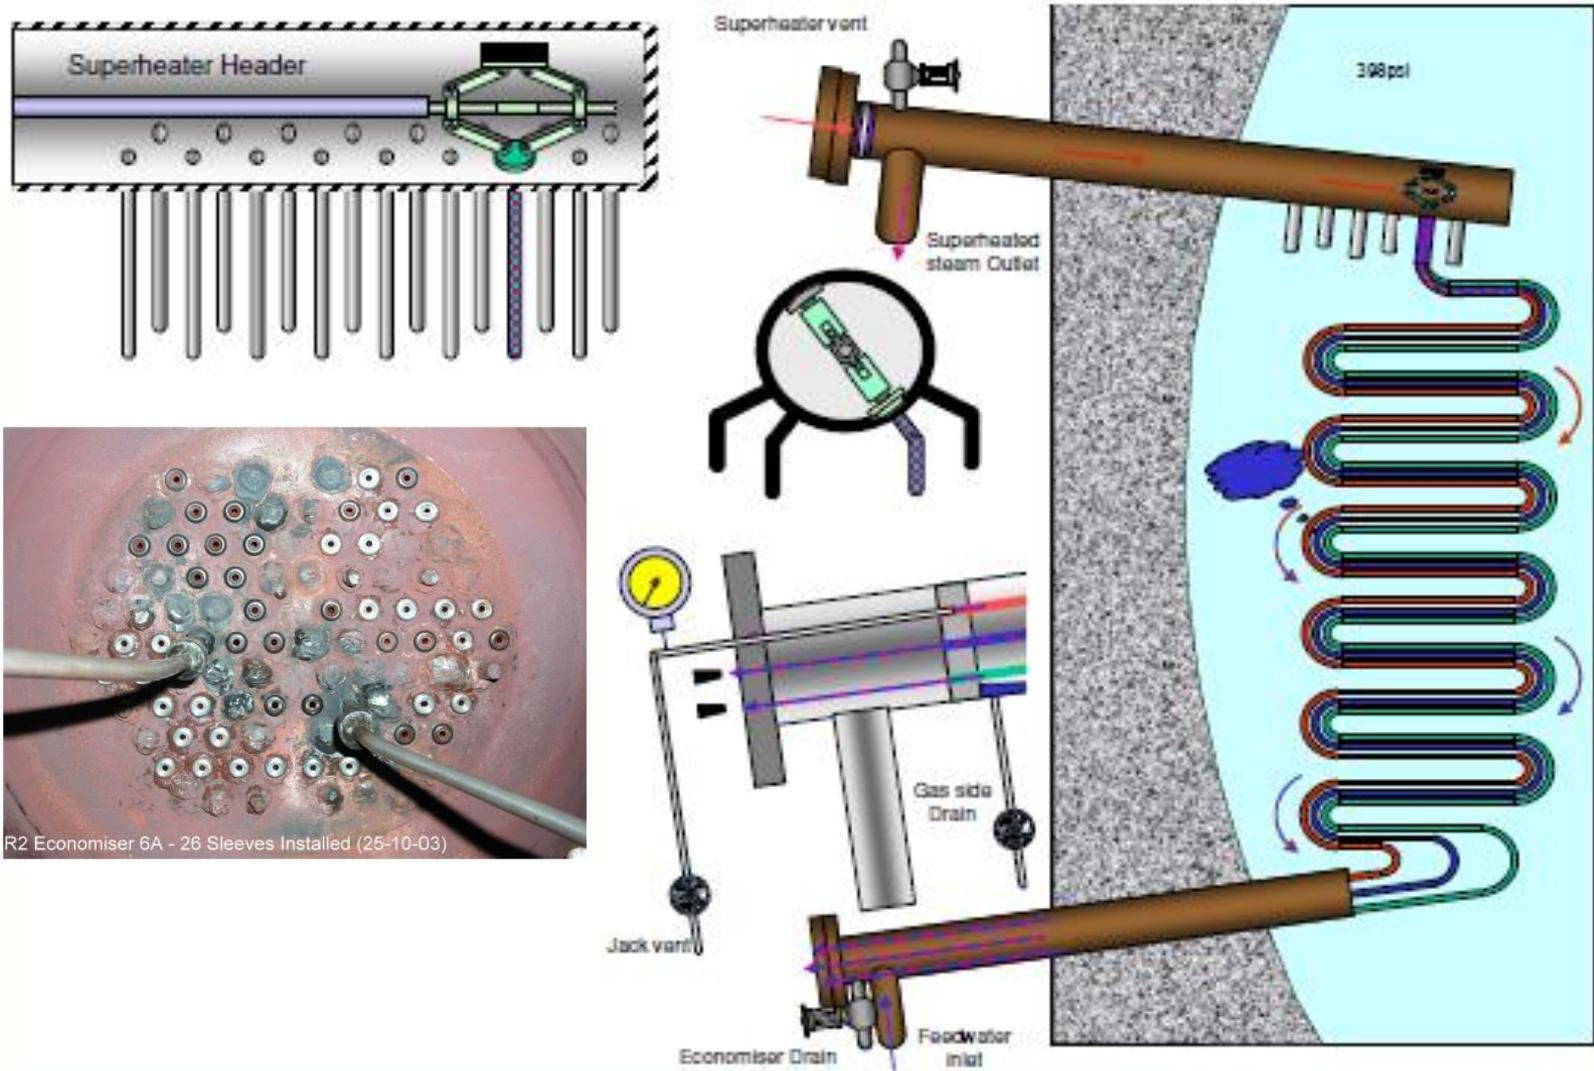
- Finding and repairing leaks is very time consuming

- Leaks cause loss of generation during repair and permanent loss of boiler tube surface

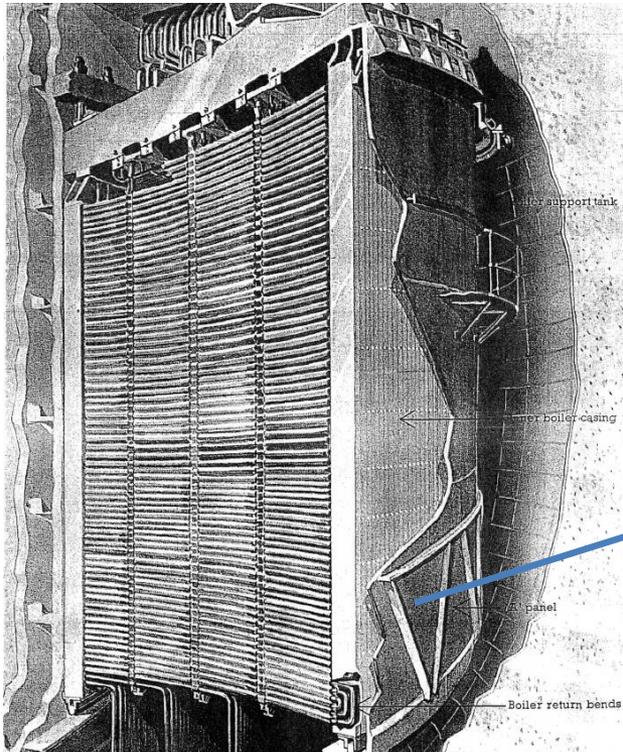
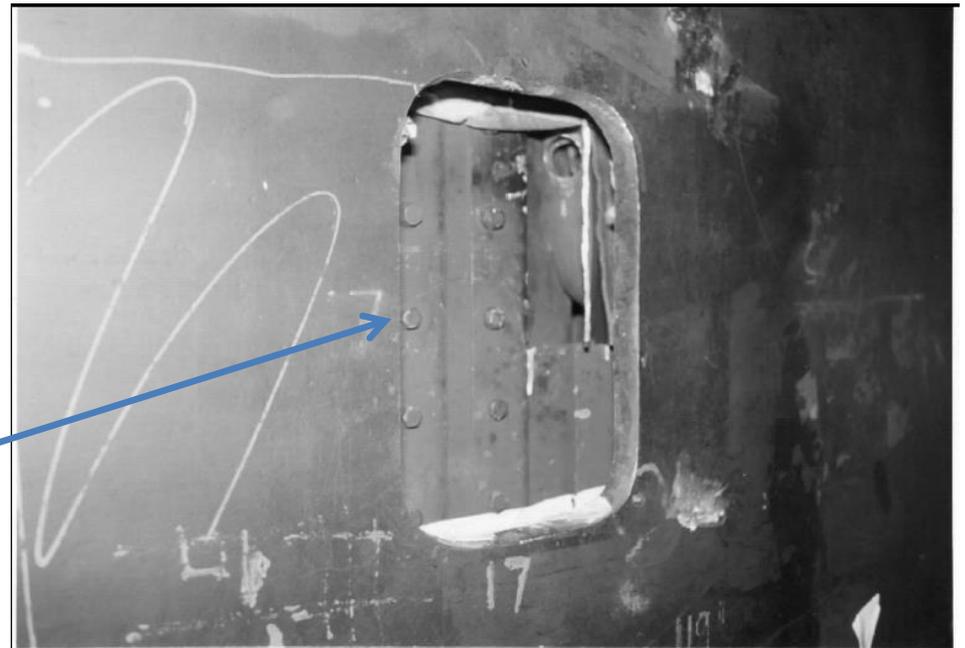
- Reactor 2 leak incidence increased and by mid 1974 leaks were occurring every few days, mostly initially on platen 16 in a packet, with some later leaks on platen 1
- Reactor 2 was shut down for investigation
- Leak heights were found by manometric and /or acoustic means and an access hole was cut in the outer wall of the boiler tank to inspect a leak site

- Problem revealed to be due to fretting between the unfinned section of the boiler tube and the “seagull” clip

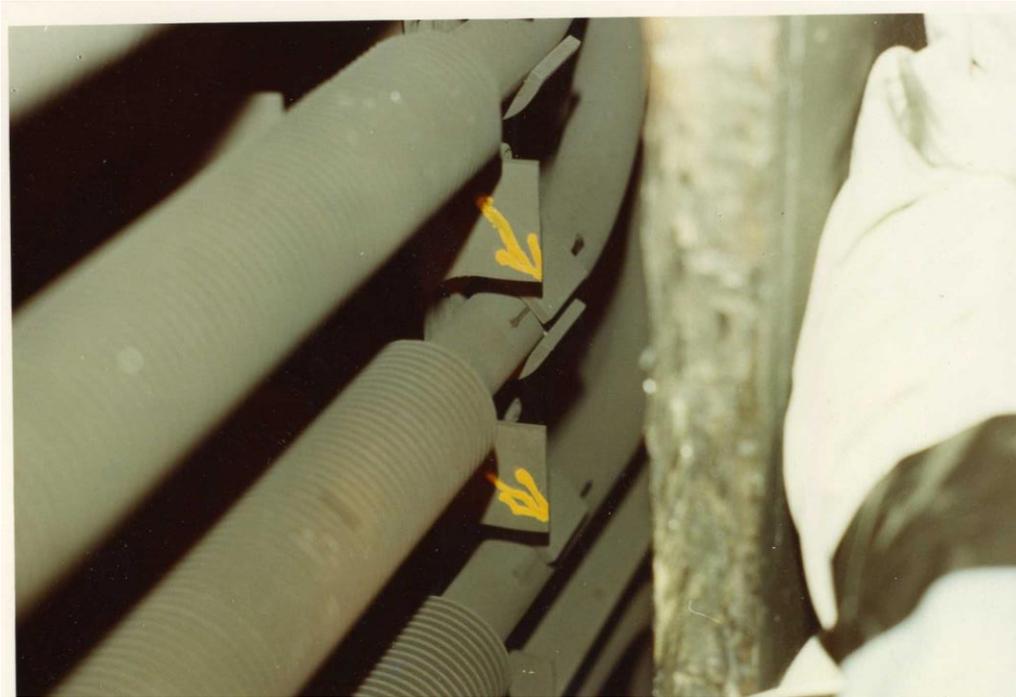
- Fibre-optic inspection showed that only end-of-packet tubes in the economiser were damaged where boiler packets had moved relative to each other and opened ~1" gaps
- Extensive instrumentation was fitted and gas circulator runs revealed vertical resonance of the tubes at the vortex shedding frequency of the gas travelling up the larger inter-packet gaps

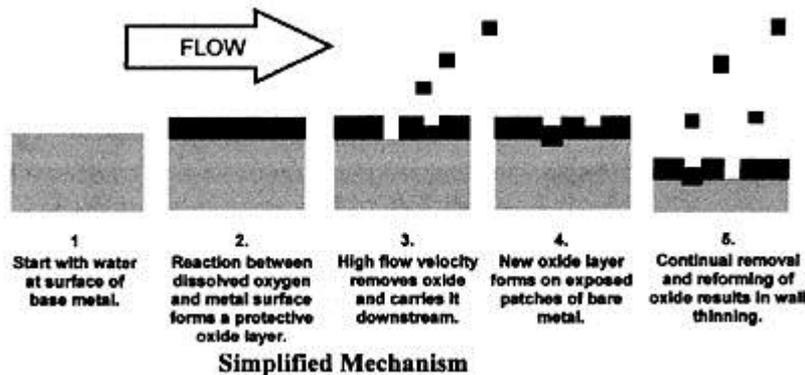
- A different population of leaks started in Reactor 1 in 1975
- Initial investigations showed these were caused by two-phase erosion-corrosion in the 1" OD economiser tube bends on the platens nearest the access ways (packets 1,31,32,62)

- Tubes here ran hotter causing boiling to occur lower with the steam-water mixture increasing the flow resistance further driving the boiling point lower. Thus boiling was occurring in the small bore economiser at higher velocity rather than the larger bore evaporator at lower velocity
- Once an access way platen has been plugged the problem transfers to the next platen
- In Reactor 1 the first 10 platens in packet 31 have been lost

- Two basic approaches were followed to counter the problem:
- Firstly the pressures in the penetrations feeding access way platens were increased to increase flows in these platens with the other platens fed from the penetration ferruled to bring their flows back to design

- Secondly the liquid phase pH was increased to reduce the two-phase erosion-corrosion in all platens
- Reactor 2 started to suffer from the problem in 1979, catching up after its fretting shutdown

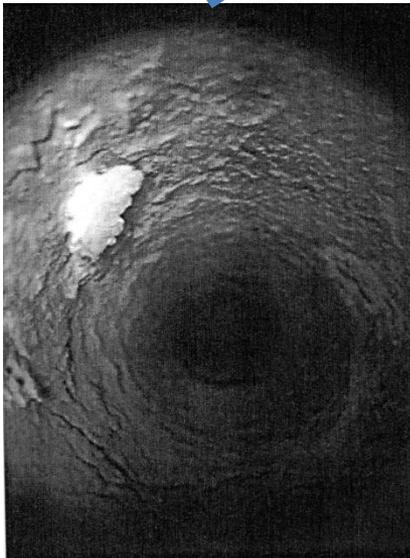
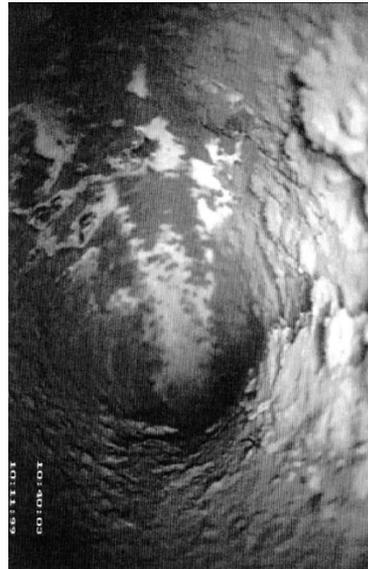
- Waterside video inspections were possible by vessel entry and cutting superheater tailpipes to provide access for specially designed cameras

- Inspections in the April 1999 R1 outage confirmed the presence of on-load corrosion scabs
