# History of the Wylfa Boilers

An Exercise in Problem Solving

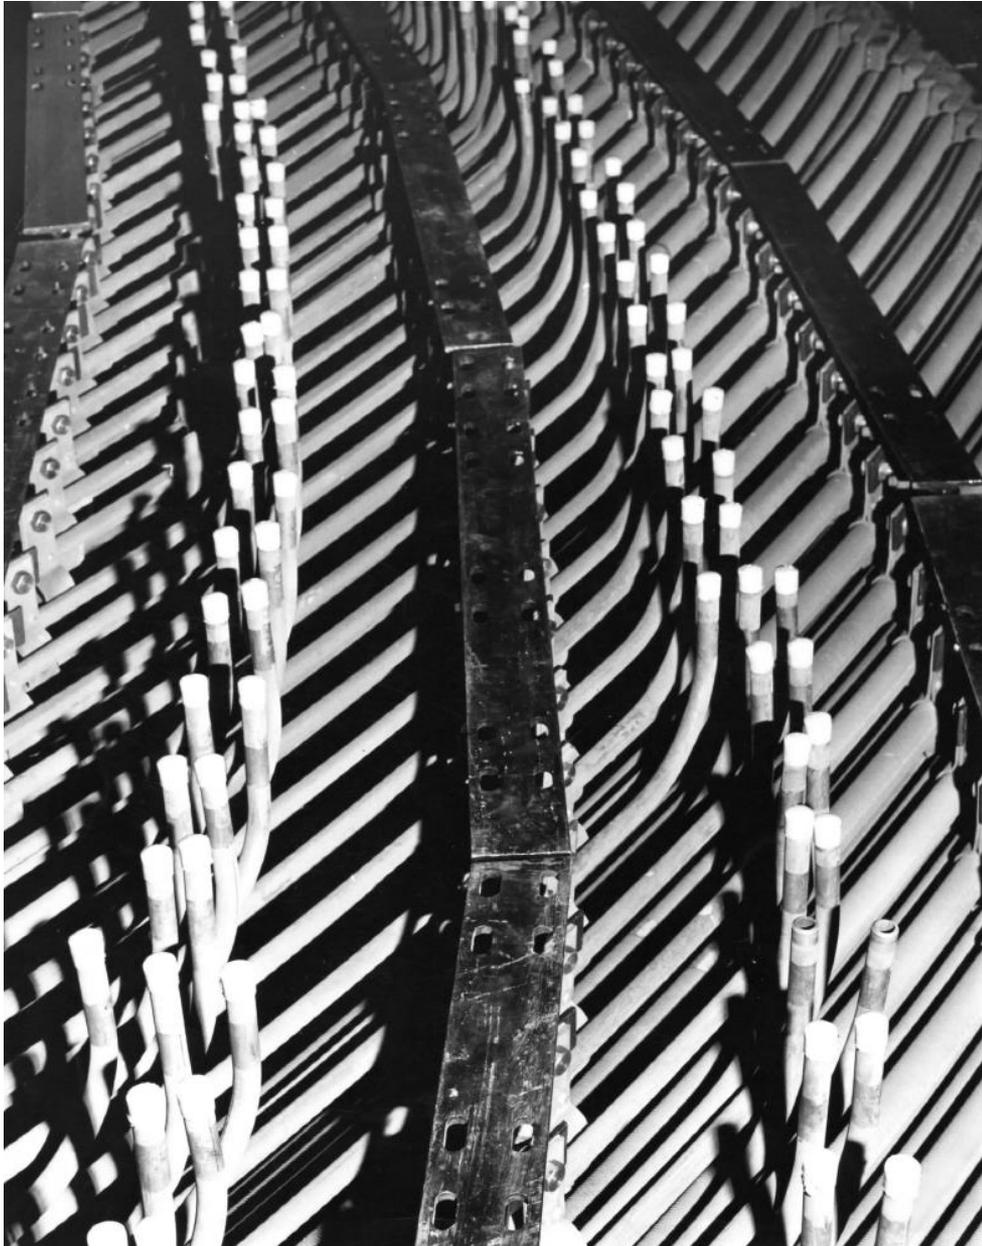
- Top of superheater boiler tubes during construction to illustrate the density of finned tubing

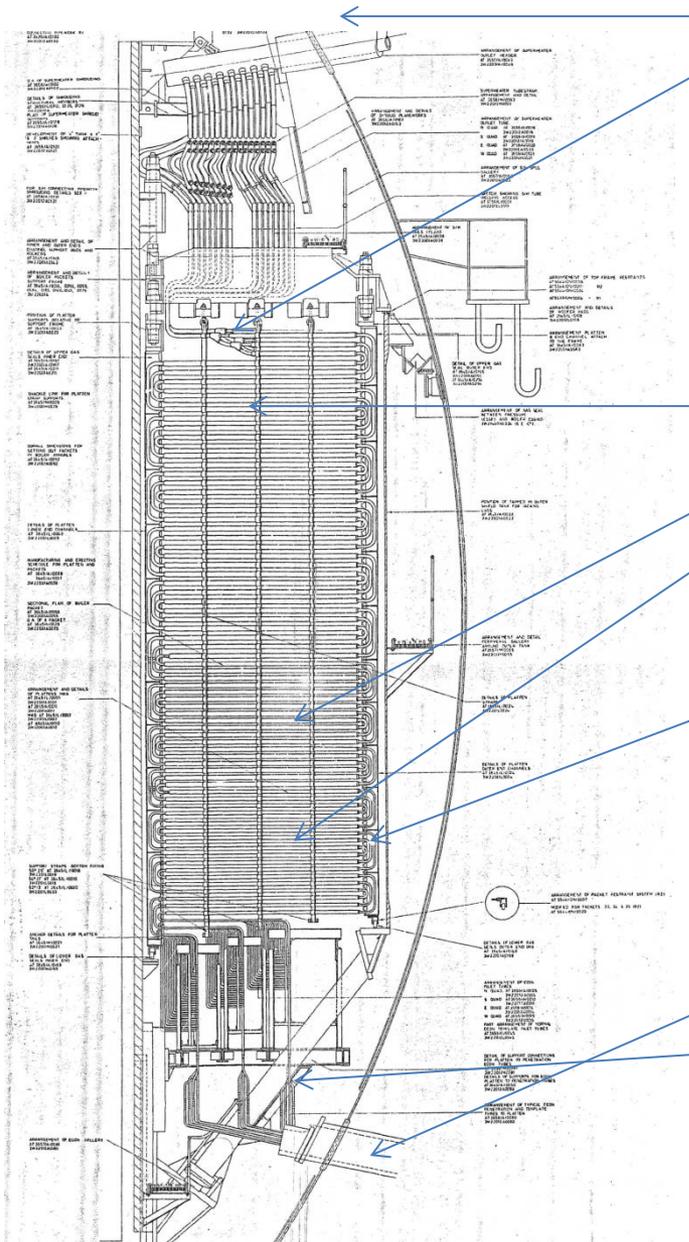
- The three tubes are joined at the top of the platen through two bifurcations before connecting to a superheater header

- Each tube is 240 ft long fabricated from mild steel finned tube in three sections:
  - 1.5" OD superheater (30mm ID)
  - 1.25" OD evaporator (24mm ID)
  - 1" OD economiser (18mm ID)

- Unfinned return bends are baffled in end-channel sections so no heat input at bends

- Each tube fed separately at the bottom from an economiser waterbox via 18' of 0.3" NB restrictor tube

- A platen consists of three boiler tubes interleaved in three serpentines from bottom to top

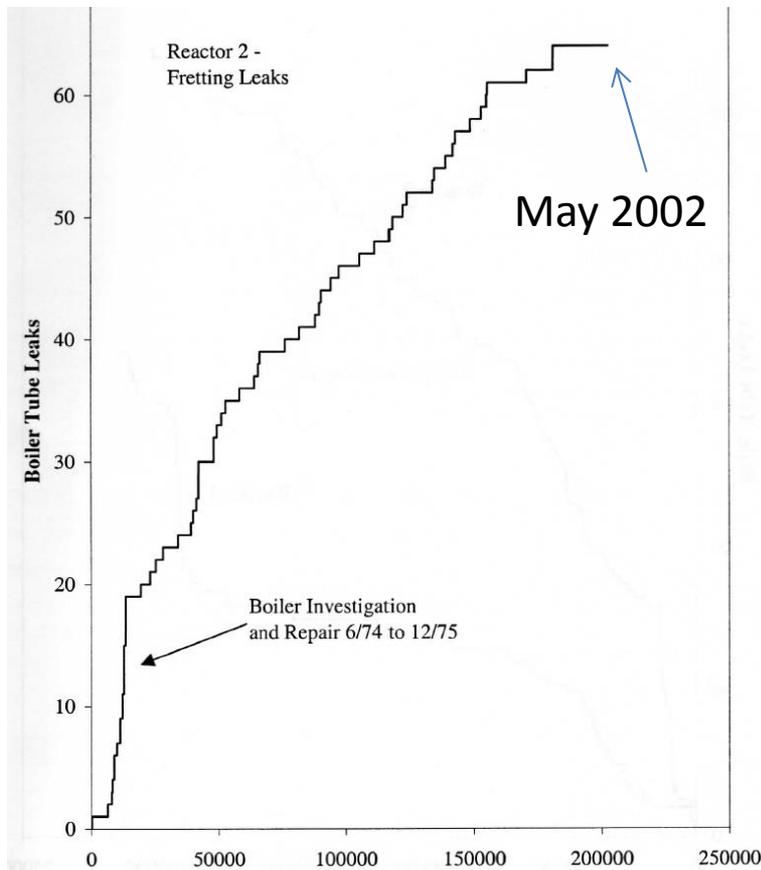
- Reactor 2 returned to power in January 1976, after an outage of 19 months
- After 70 days running and an internal inspection it received final clearance in the late summer of 1976.
- Failure rate much reduced, but occasional failures in platens 1, 16 and 2, 15

• No R1 fretting leaks!

• R2 fretting leaks were made manageable by many engineers and scientists at Wylfa and other CEBG scientific and engineering support and research facilities

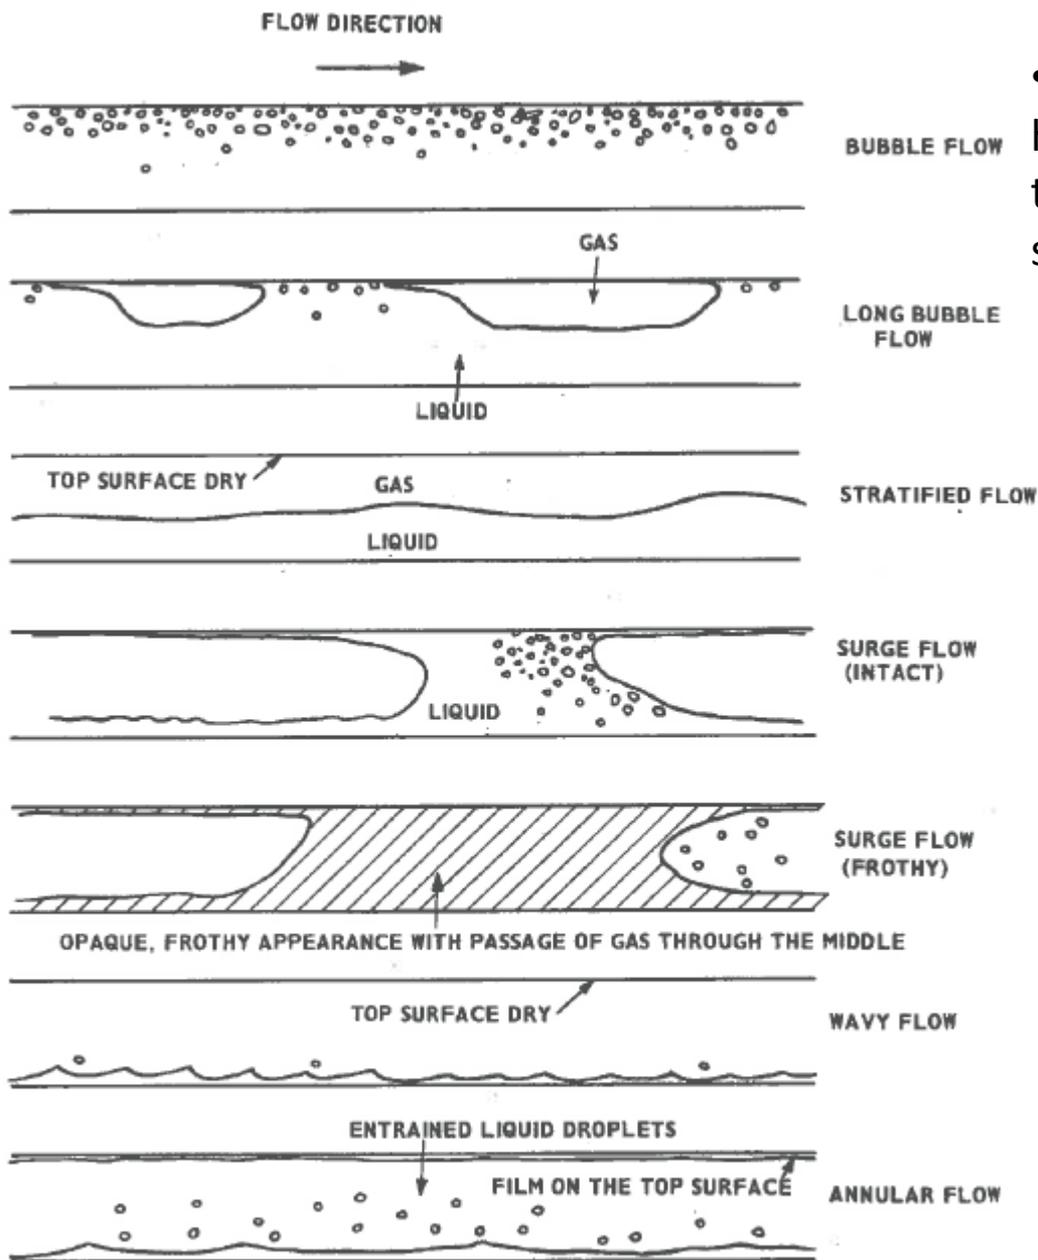
- Tubes here ran hotter causing boiling to occur lower with the steam-water mixture increasing the flow resistance further driving the boiling point lower. Thus boiling was occurring in the small bore economiser at higher velocity rather than the larger bore evaporator at lower velocity
- Once an access way platen has been plugged the problem transfers to the next platen
- In Reactor 1 the first 10 platens in packet 31 have been lost

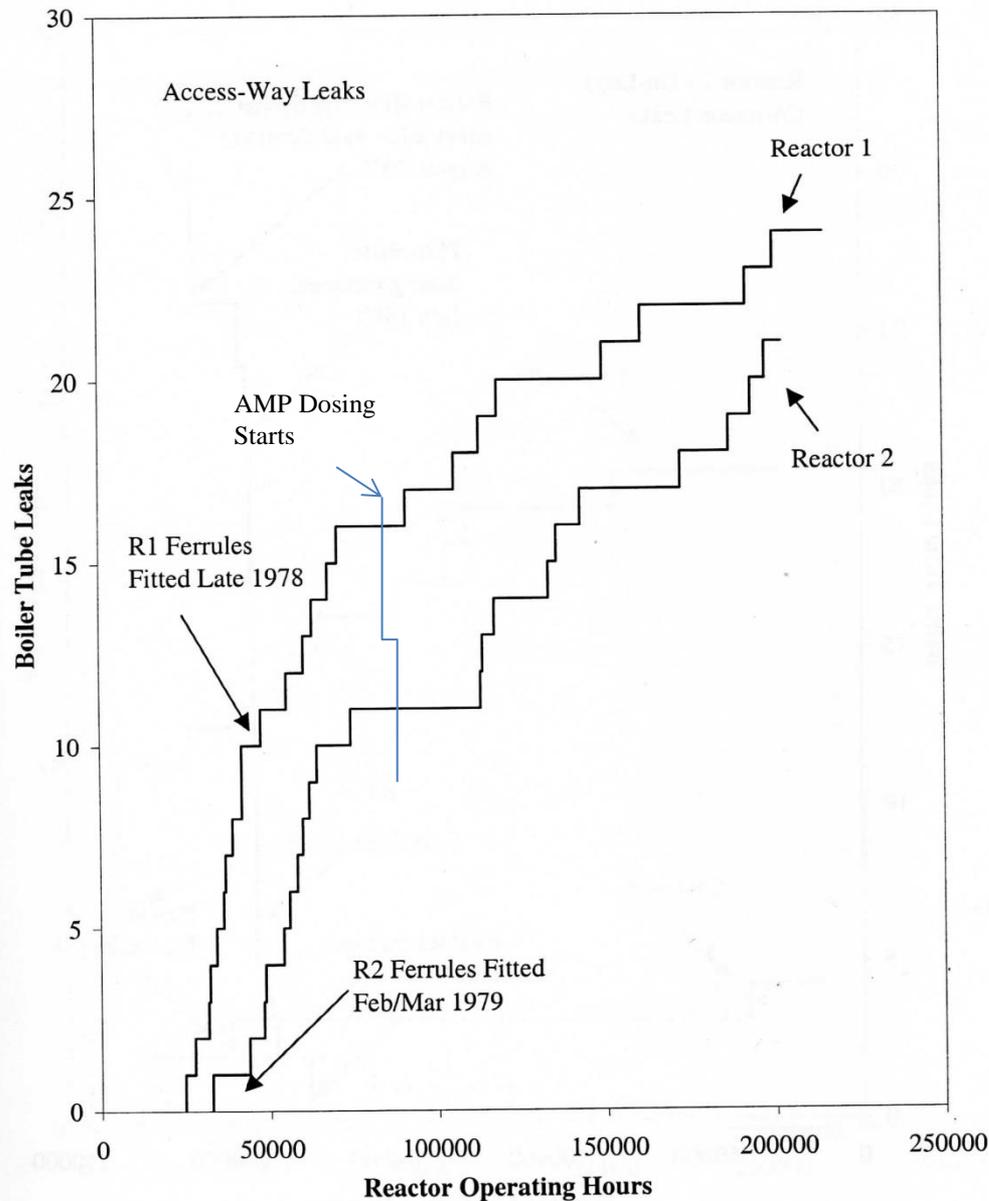
- Tube heated by passing current through it
- ~0.5 MW of electrical heating
- Removable bends for testing
- Test bends subject to proton beam irradiation to produce a layer of  $^{56}\text{Co}$  to an ~80 $\mu\text{m}$  depth to enable a metal loss measurement sensitivity of  $\pm 0.1\mu\text{m}$
- Outcome was change from ammonia dosing to Amino Methyl Propanol (AMP) in 1983 and to 5-aminopentanol (5AP) in 1992, mainly to protect the 30mm ID superheater tubes

- Access-Way (Erosion-Corrosion) leaks brought under control
  - Still occur but at a manageable rate
  - No erosion-corrosion failures of 30mm ID superheater tubes
- The CEGB developed some of the country's leading hydrodynamicists in the 1980s**

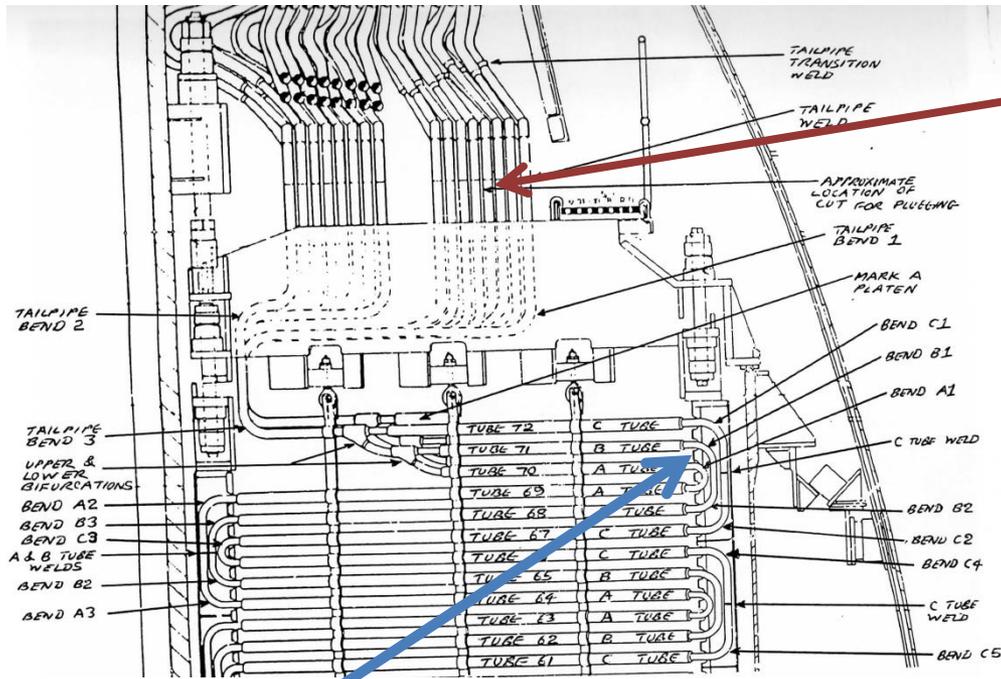
- The third leak-producing mechanism to afflict the Wylfa boilers started in Reactor 1 early 1996 and escalated rapidly in 1998 when the rate of boiler leak occurrence was worse than the fretting period of 1973/1974
- Based on experience of conventional stations the cause was thought likely to be on-load corrosion where the normally protective magnetite coating of the inside of the boiler tube becomes pitted and scabbed until the scab breaks away often to produce a leak
- This occurs high in the boiler around the point of final dry-out
- Phosphate dosing had stopped in 1994 when 5AP was introduced on the mistaken belief that 5AP would raise the pH sufficiently to protect the dry-out zone
- As an immediate countermeasure phosphate dosing resumed in July 1998 to ensure that corrosive acidic conditions could not exist under corrosion scabs

- Waterside video inspections were possible by vessel entry and cutting superheater tailpipes to provide access for specially designed cameras

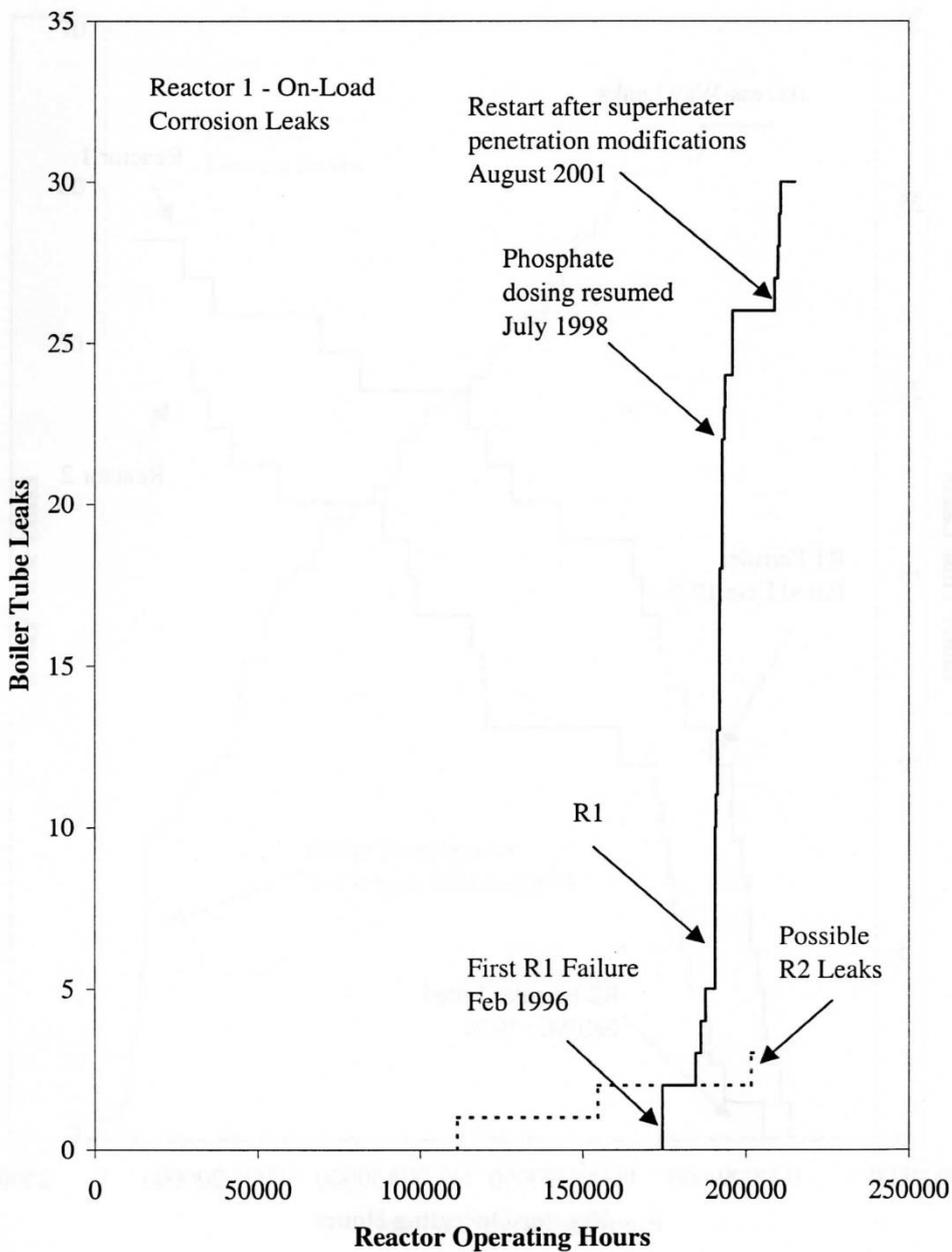
- Inspections in the April 1999 R1 outage confirmed the presence of on-load corrosion scabs

•Leak occurrence rate reduced but residual damage took time to work through:

2003: 4  
 2004: 1  
 2005: 3  
 2006: 2  
 2007: 4  
 2008: 1  
 2009: 2  
 2010: 1  
 2011: 0  
 2012: 0  
 2013: 1  
 2014: 0  
 2015: 0
